The Athens earthquake (7 September 1999): intensity distribution and controlling factors

E. Lekkas*

Department of Geology, University of Athens, Panepistimioupoli Zografou, 15784 Athens, Greece

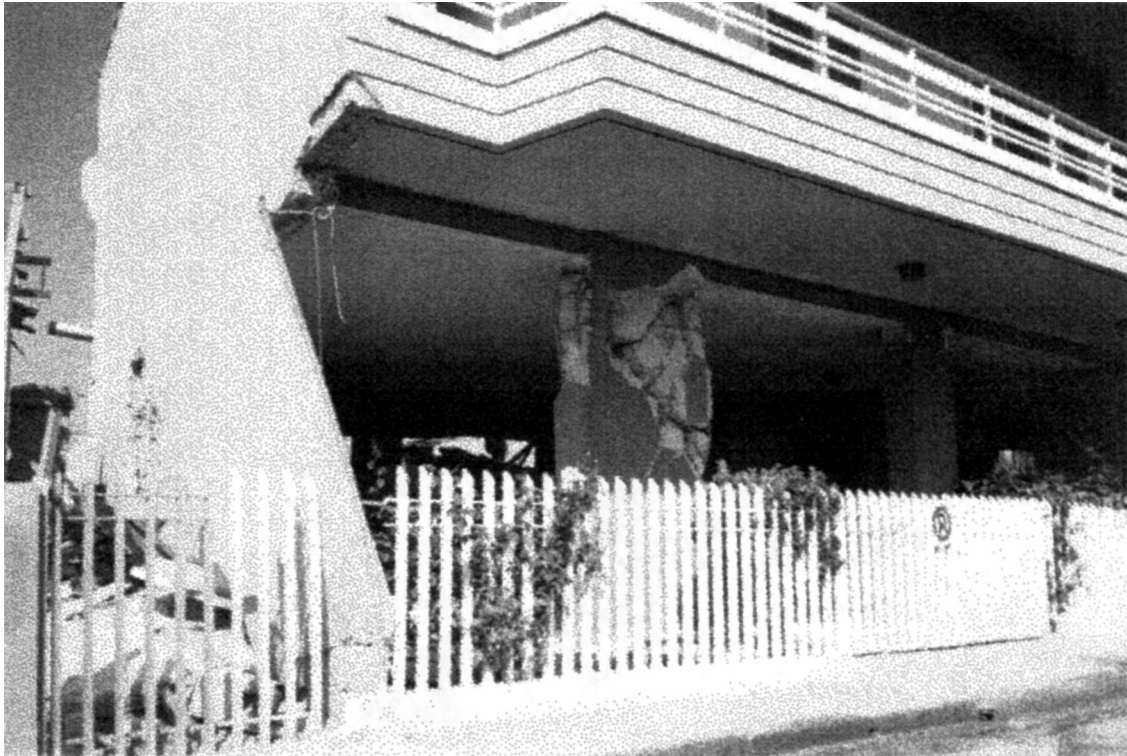
Fig. 5. Reinforced concrete column failure of a single-story building with damage degree 4 in Ano Liosia.

- *Damage to buildings with a soft ground floor (pilotis).* Buildings with a soft ground floor are a common practice in Greece. Significantly less rigidity in this floor, compared to the rest of the building, leads to large deformations of the soft story. The damage occurred mainly on the joints, which were totally destroyed in a number of cases. As a result, the structural system became a mechanism, and large permanent horizontal displacements were observed (Figs. 5 and 6).

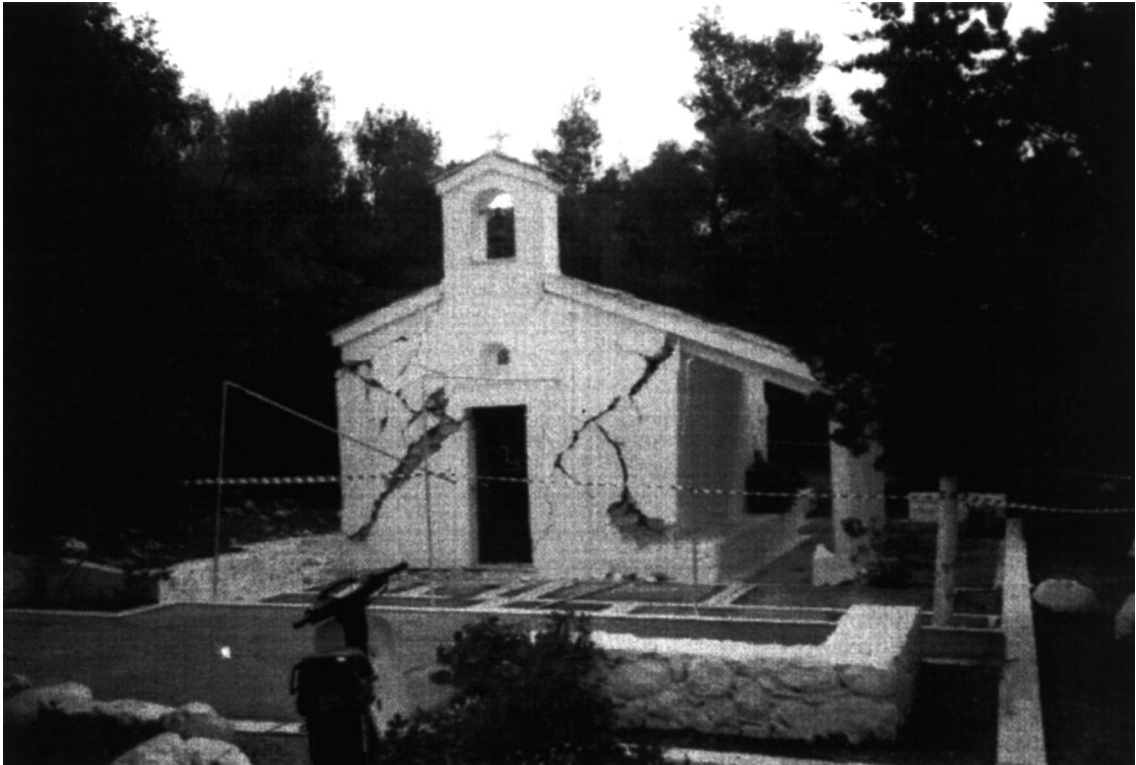
In the meizoseismal area, most abode houses and stone masonry structures with undressed stones, constructed in the first half of the century, suffered significant damage. This included partial collapse of external walls, collapse of corners, separation of the two walls converging at a corner, and extensive cracking (Fig. 7).

Fig. 7. Severe damage (Fourth degree) in a simple stone masonry church at Thrakomakedones area.

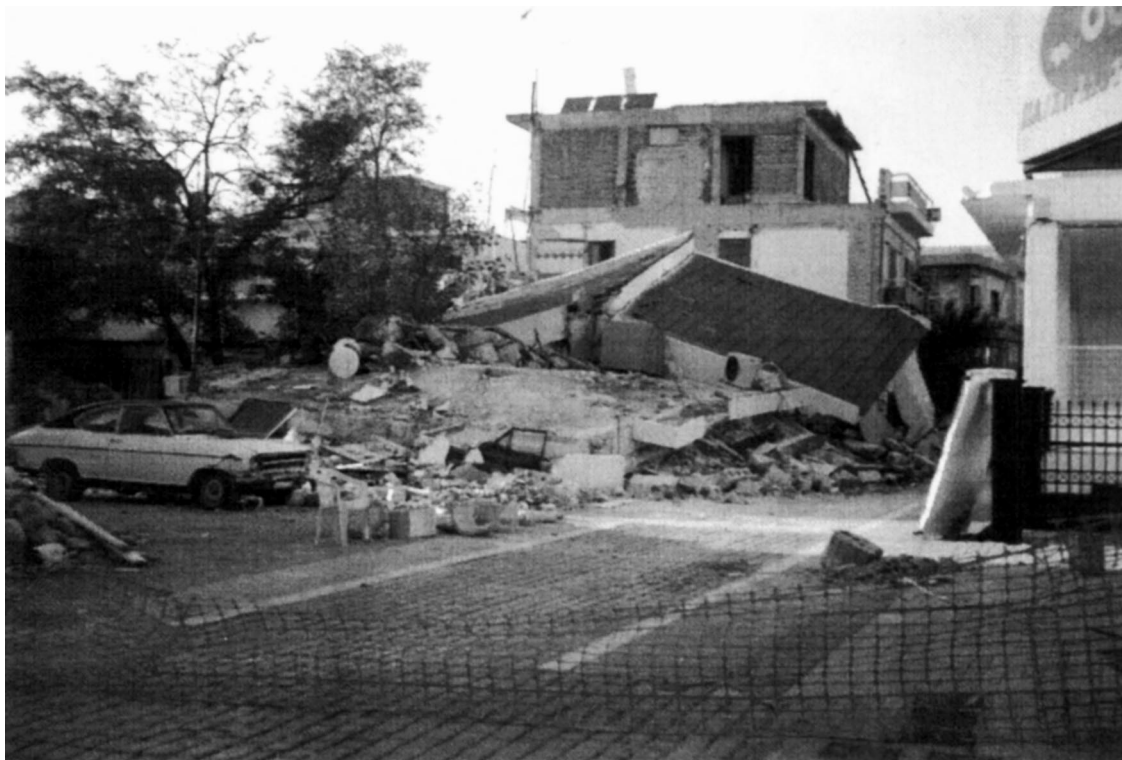
Fig. 10. A brick masonry and reinforced concrete slab construction with almost nonexistent supporting columns that collapsed in Ano Liosia.

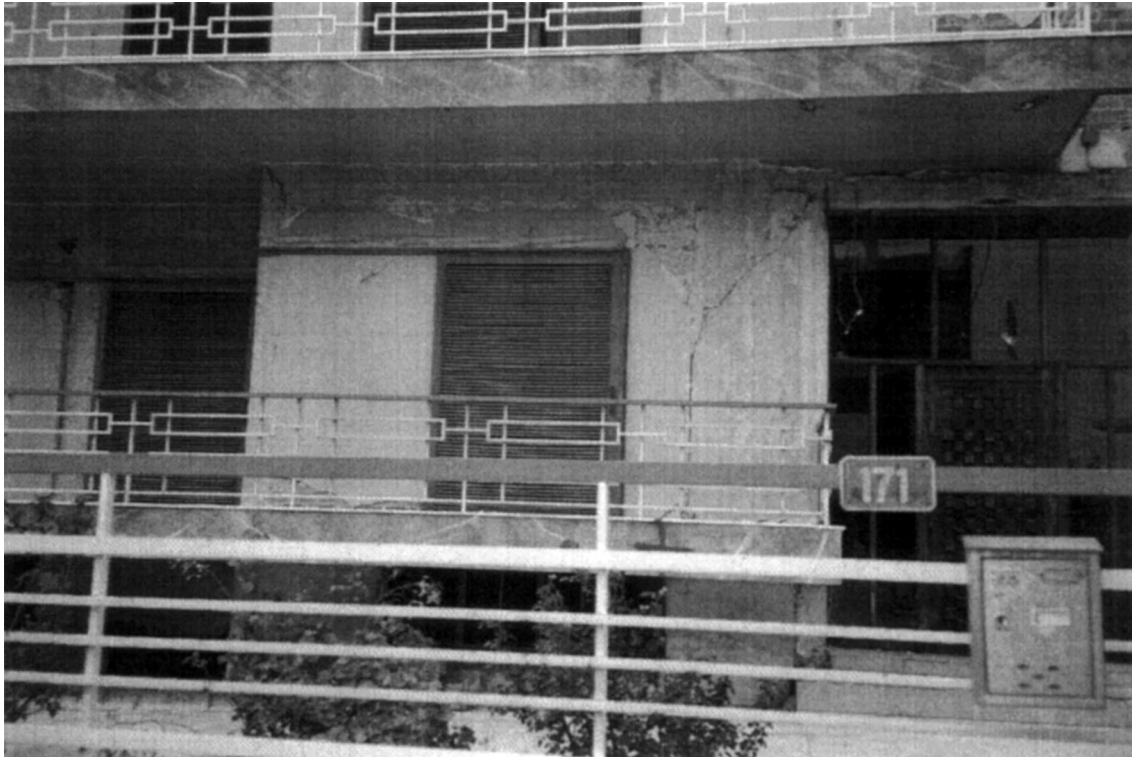
Fig. 11. Column failure of a reinforced concrete frame structure with damage degree 4 in Menidi.

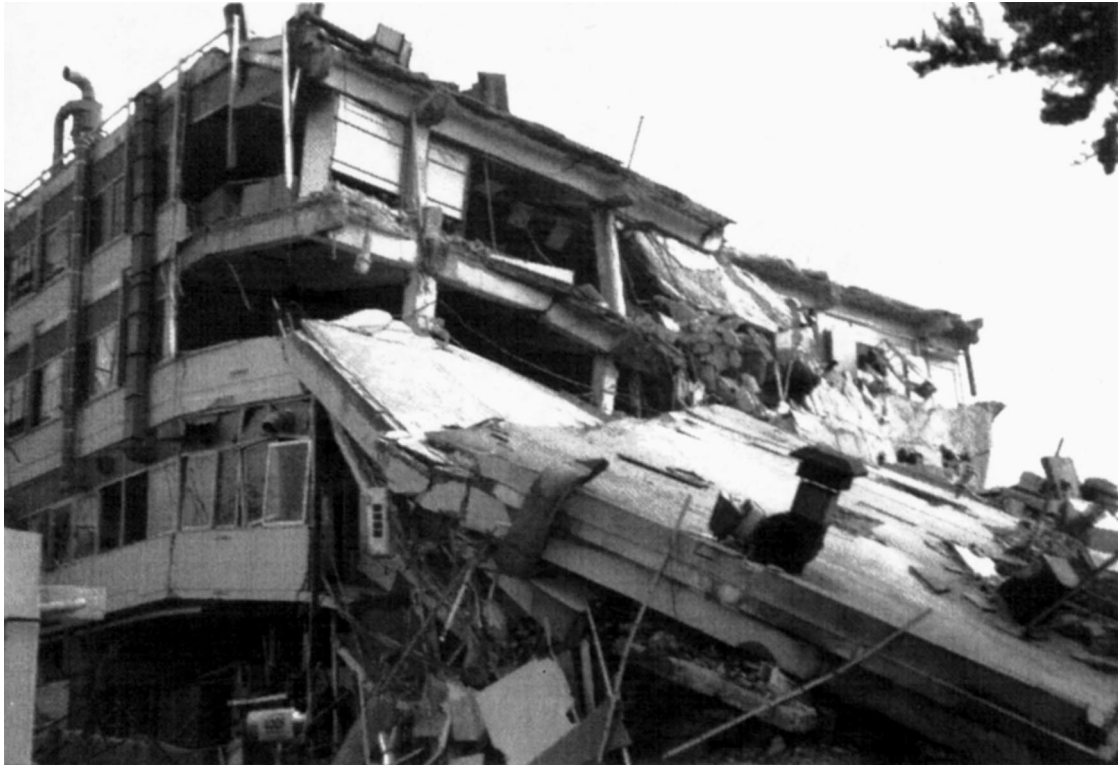
Fig. 12. Collapse of a concrete-frame pharmaceutical factory wing (damage degree 5) at Adames.

Finally, it is noteworthy that topography and, particularly the morphological discontinuities may have played an important part in some areas as at Chelidonou torrent and Adames (Fig. 12). The performance of foundation soils was not the poorest possible in these areas, so, high intensities that were almost linear-arranged may be directly correlated to the adjacent morphological discontinuities. It should be noted that in neighboring areas with the same soil profile, lithostratigraphic structure and azimuthal
